FAULTS ANALYSIS OF 33KV ELECTRICITY DISTRIBUTION SYSTEM IN THE ABEOKUTA BUSINESS HUB

This research work investigated the faults analysis usually encountered on a 33kv distribution system using the Abeokuta business hub in Ogun state, Nigeria as a case study. The available data which was analyzed statistically revealed that the bad condition of the physical structure of the 33kv distribution network was the major cause of frequent outage in Abeokuta and its environs. Accordingly, the deplorable state of the physical structure triggers most technical faults such as, short circuits, over-voltage etc. In this research work, different electrical faults were also studied, taking cognizance of the causes and how they hinder power supply to various consumers in Abeokuta city. Important components such as the feeders, distributors and the aluminium conductors of the 33kv distribution network were assessed. The study was extended to the 33/11kv distribution system and effects of faults on this system were also statistically analyzed. The data collected indicated that the power available in Abeokuta was approximately 32 percent of the total load demand, and the poor state of some feeders, in

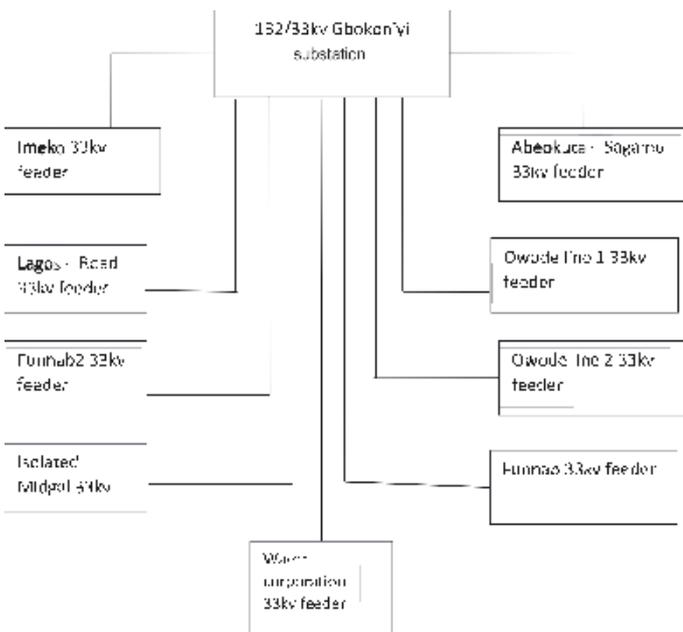
Fig.1: Block diagram of 33kv distribution system in Abeokuta

These feeders radiate from Gbokoniyi sub-station. Most of the feeders are vulnerable to frequent fault as a result of excessive load current.

Figure 1 illustrates the block diagram of 33kv distribution system in Abeokuta and its environs.

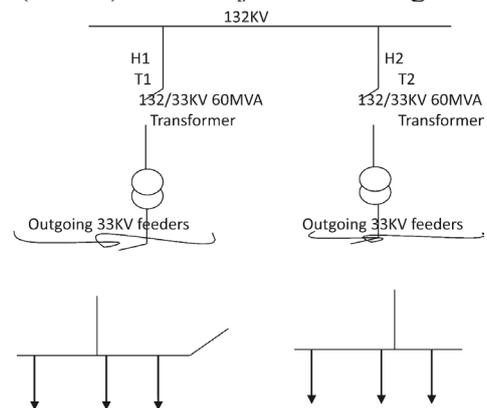
Fig. 2: One line schematic diagram of newly constructed 132/33kv sub-station along Abeokuta – Sagamu Express Road

The sub-station is designed with two (2) 60MVA power distribution transformers, current transformers, voltage transformers, isolators, SF6 circuit breakers, 132kv gantry, 33kv gentry, Aluminum steel reinforced conductors (250mm²), etc. It is designed to supply Funnab, Siun, Owode, and others so as to stabilize power in these areas and give a pressure and load relief to the existing Gbokoniyi sub-station. The schematic diagram of the newly constructed 132/33kv sub-station is illustrated in Figure 2.

It is pertinent to note that the sub-station receives its bulk power (132kv) from Ikeja West through Ota.

Figure 2 shows that the sub-station is very flexible and reliable in such a way that either or both power transformers can be engaged to supply three (3) feeders or all the six (6) feeders at a point in time (Brown, 1988; Onohaebi, 2009). In the same vein, each circuit can be isolated to carry out maintenance and repair activities if required. Isolators (H) are equally installed on each outgoing feeder to control its circuit as desired by the technical personnel in the sub-station, and this enhances the flexibility of the system.
